**ECOLOGICAL ASSESSMENT OF WATERWAYS
WITHIN TE PUNA SPRINGS ESTATE,
23 TE PUNA ROAD, TAURANGA**

Contract Report No. 6278

May 2022

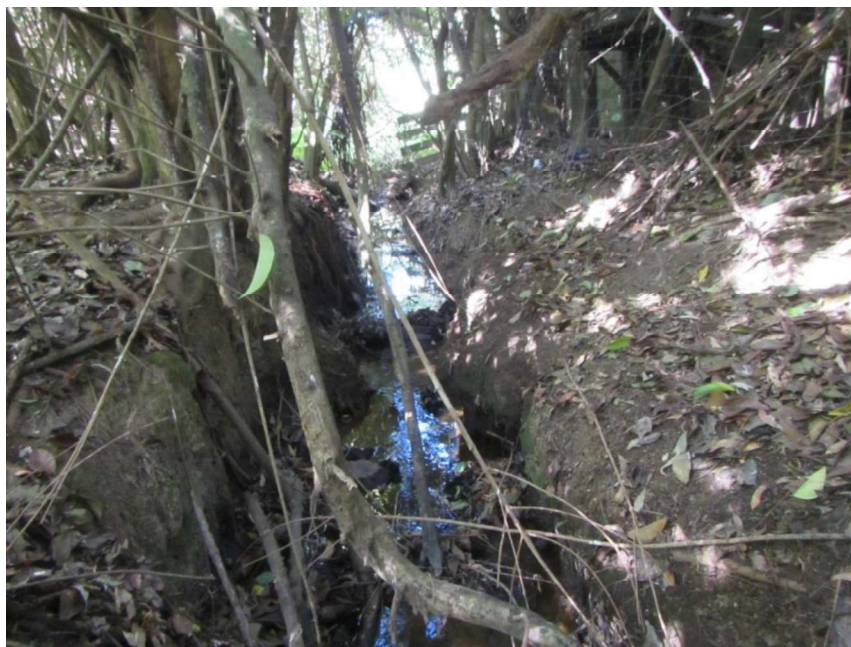
Tree privet forms a dense canopy up to eight metres tall on the margins of the stream in the northern half of the site. The understorey and groundcover is depauperate with only occasional small patches of *Diplazium australe* within bare ground. Occasional Lombardy poplar (*Populus nigra* 'Italica') and flowering cherry (*Prunus* species) are also present in the canopy.

Plate 1: Main northern stream channel near the northern property boundary. The main cover is tree privet stems and vegetation diversity is lacking. 2 March 2022.

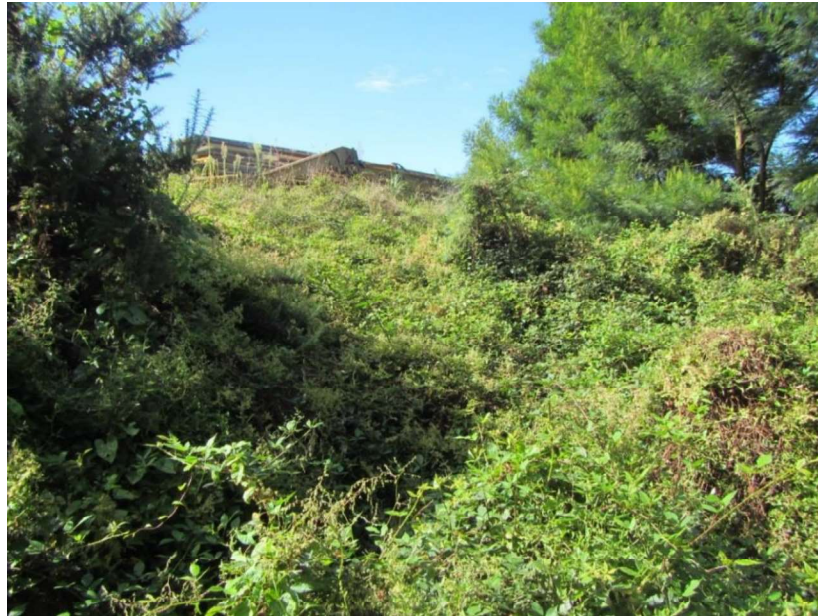
Upper riparian margins on the eastern side of the lower stream reach support vineland dominated by blackberry (*Rubus fruticosus*) and climbing dock (*Rumex sagittatus*) with occasional emergent gorse (*Ulex europaeus*), flowering cherry, and black wattle (*Acacia mearnsii*). These areas also have a narrow strip of exotic grassland and herbfield at the top of the slope.

Plate 2: Blackberry and climbing dock vineland on the upper eastern riparian margins in the northern half of the site. 2 March 2022.

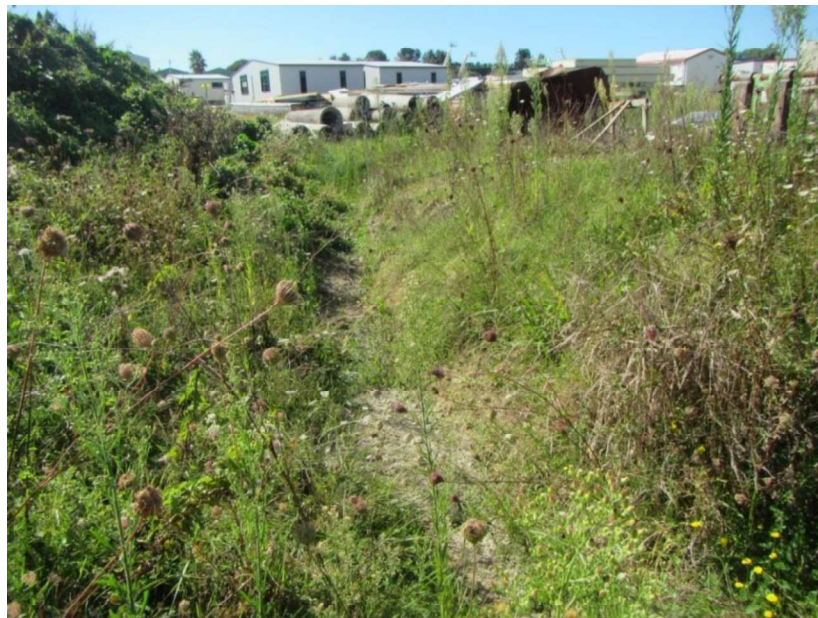
A small area of grassland and herbfield dominated by exotic species on flat, compacted ground beside and within an ephemeral flow path. Species present include broadleaved fleabane, wild carrot (*Daucus carota*), paspalum (*Paspalum dilatatum*), Mercer grass (*Paspalum distichum*), summer grass (*Digitaria sanguinalis*), sweet vernal (*Anthoxanthum odoratum*), narrow leaved plantain (*Plantago lanceolata*), and creeping buttercup (*Ranunculus repens*).

Plate 3: A small ephemeral flow path surrounded by mixed exotic grassland and herbfield. 2 March 2022.

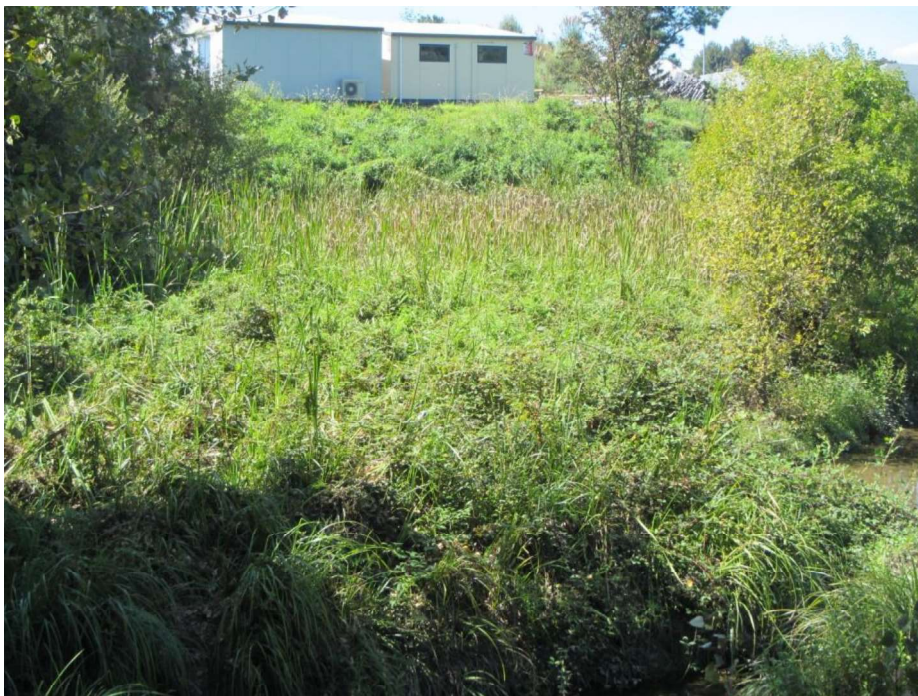
A small area of wetland habitat is present on the northeastern side of the pond in the centre of the main watercourse. Raupō (*Typha orientalis*) reedland with lesser proportions of *Carex geminata* and swamp millet (*Isachne globosa*) dominates the eastern half of this area, with *Carex geminata* becoming more dominant towards the open water habitat. *Diplazium australe* is locally common amongst the *Carex* dominated area, and occasional small blackberry canes and Japanese honeysuckle (*Lonicera japonica*) vines are also present towards the drier margins of this type.

Plate 4: A small area of indigenous wetland habitat dominated by raupō and *Carex geminata* is present beside the existing pond. 2 March 2022.

The small area of indigenous-dominated wetland habitat located on the northeastern margin of the pond is representative of a common wetland habitat beside an area of open water area in Tauranga Ecological District and contains the expected plant species

and diversity. It is likely to provide occasional habitat for pūkeko. Although freshwater wetlands have been greatly reduced in extent within Tauranga Ecological District (Wildland Consultants 2008), the wetland habitat around the pond appears to have developed following construction of the pond c.13 years ago. Therefore, although the wetland habitat is of relatively high ecological value, it does not constitute natural wetland habitat.

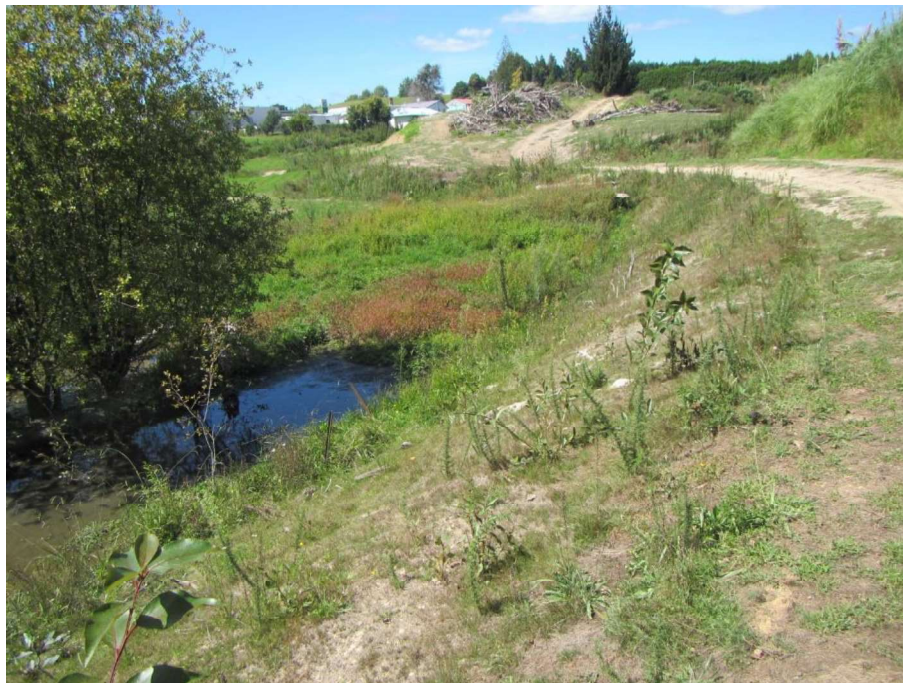
A small, narrow area of compacted fill which supports a patchy distribution of an unidentified exotic grass and scattered gorse and tree privet seedlings.

Plate 5: Compacted fill on the western side of the pond. A range of exotic species is regenerating, including grasses, gorse, and tree privet. 2 March 2022.

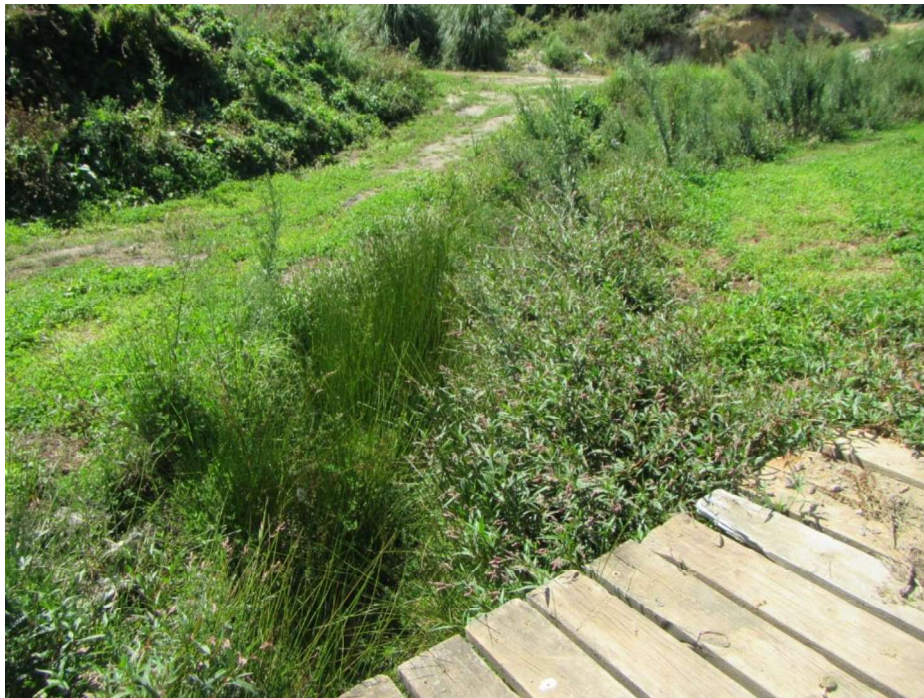
A narrow strip of unmown vegetation is present alongside the main stream channel. The stream banks support either exotic herbfield dominated by broadleaved fleabane, or supports patches of tutunawai and soft rush with creeping buttercup also common. Sharp-fruited rush is locally common.

Plate 6: The main stream channel south of the pond supports a narrow strip of riparian vegetation dominated by soft rush and tutunawai. 2 March 2022.

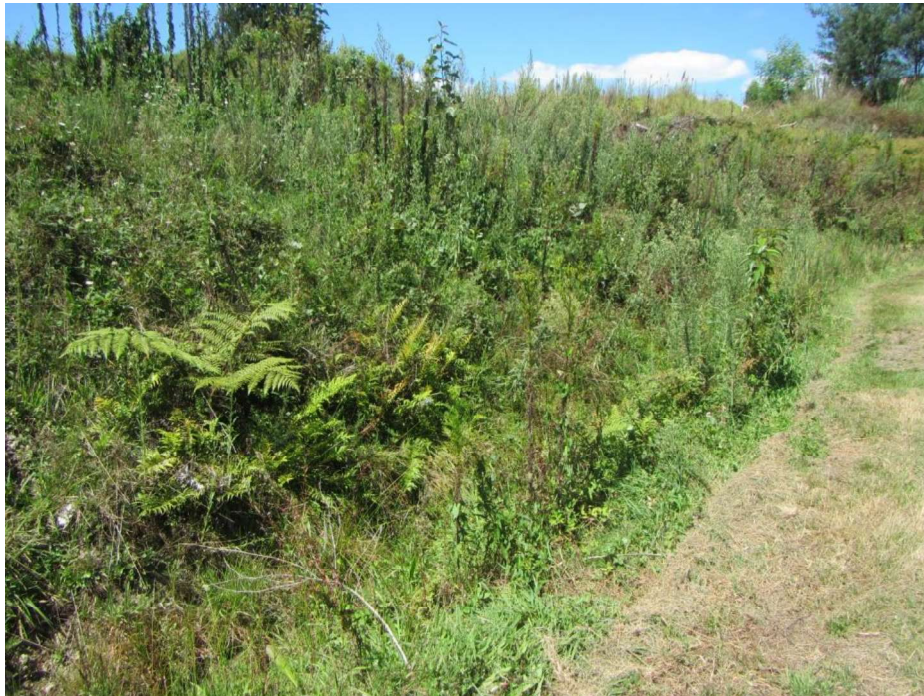
The banks of this small, narrow stream channel support a diverse range of regenerating exotic herbs as well as scattered regenerating woody species, and small, local patches of kiokio (*Blechnum novae-zelandiae*) and *Diplazium australe*.

Plate 7: The southwestern tributary is small and very narrow and supports a variable width riparian margin containing a wide range of mostly exotic species. 2 March 2022.

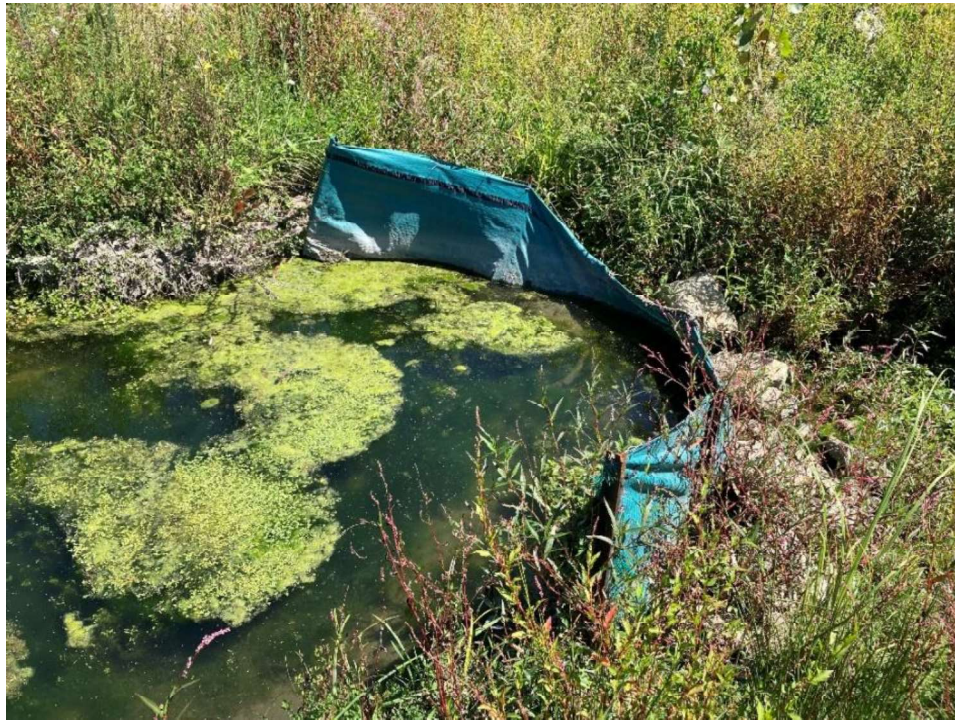
Upper reaches of the stream are located south of, and feed into, the existing pond. Water from the pond flows into the lower (northern) stream channel via a culvert under a compacted earth crossing. The upper (southern) stream reaches are fed from three different sources. The main water source appears to be a spring located near the eastern boundary of the property which is permanently flowing (Site Manager, pers. comm.). The other two streams are part of stream systems that flow from the southern side of State Highway 2 and which pass, via culverts below the road, into the southern end of the property. These two small feeder streams flow into the main stream a little above the pond before flowing down through a sediment trap then into the pond. A small area of pooling has formed upstream of the sediment trap as the water velocity has been retarded in this area due to the trap (Plate 8). The sediment trap was installed at this location c.18 months ago, prior to earthworks and vegetation clearance around the waterways (Site Manager, pers. comm.).

Plate 8: Sediment trap just above the pond which has enabled a small pool of water to bank up behind it. 2 March 2022.

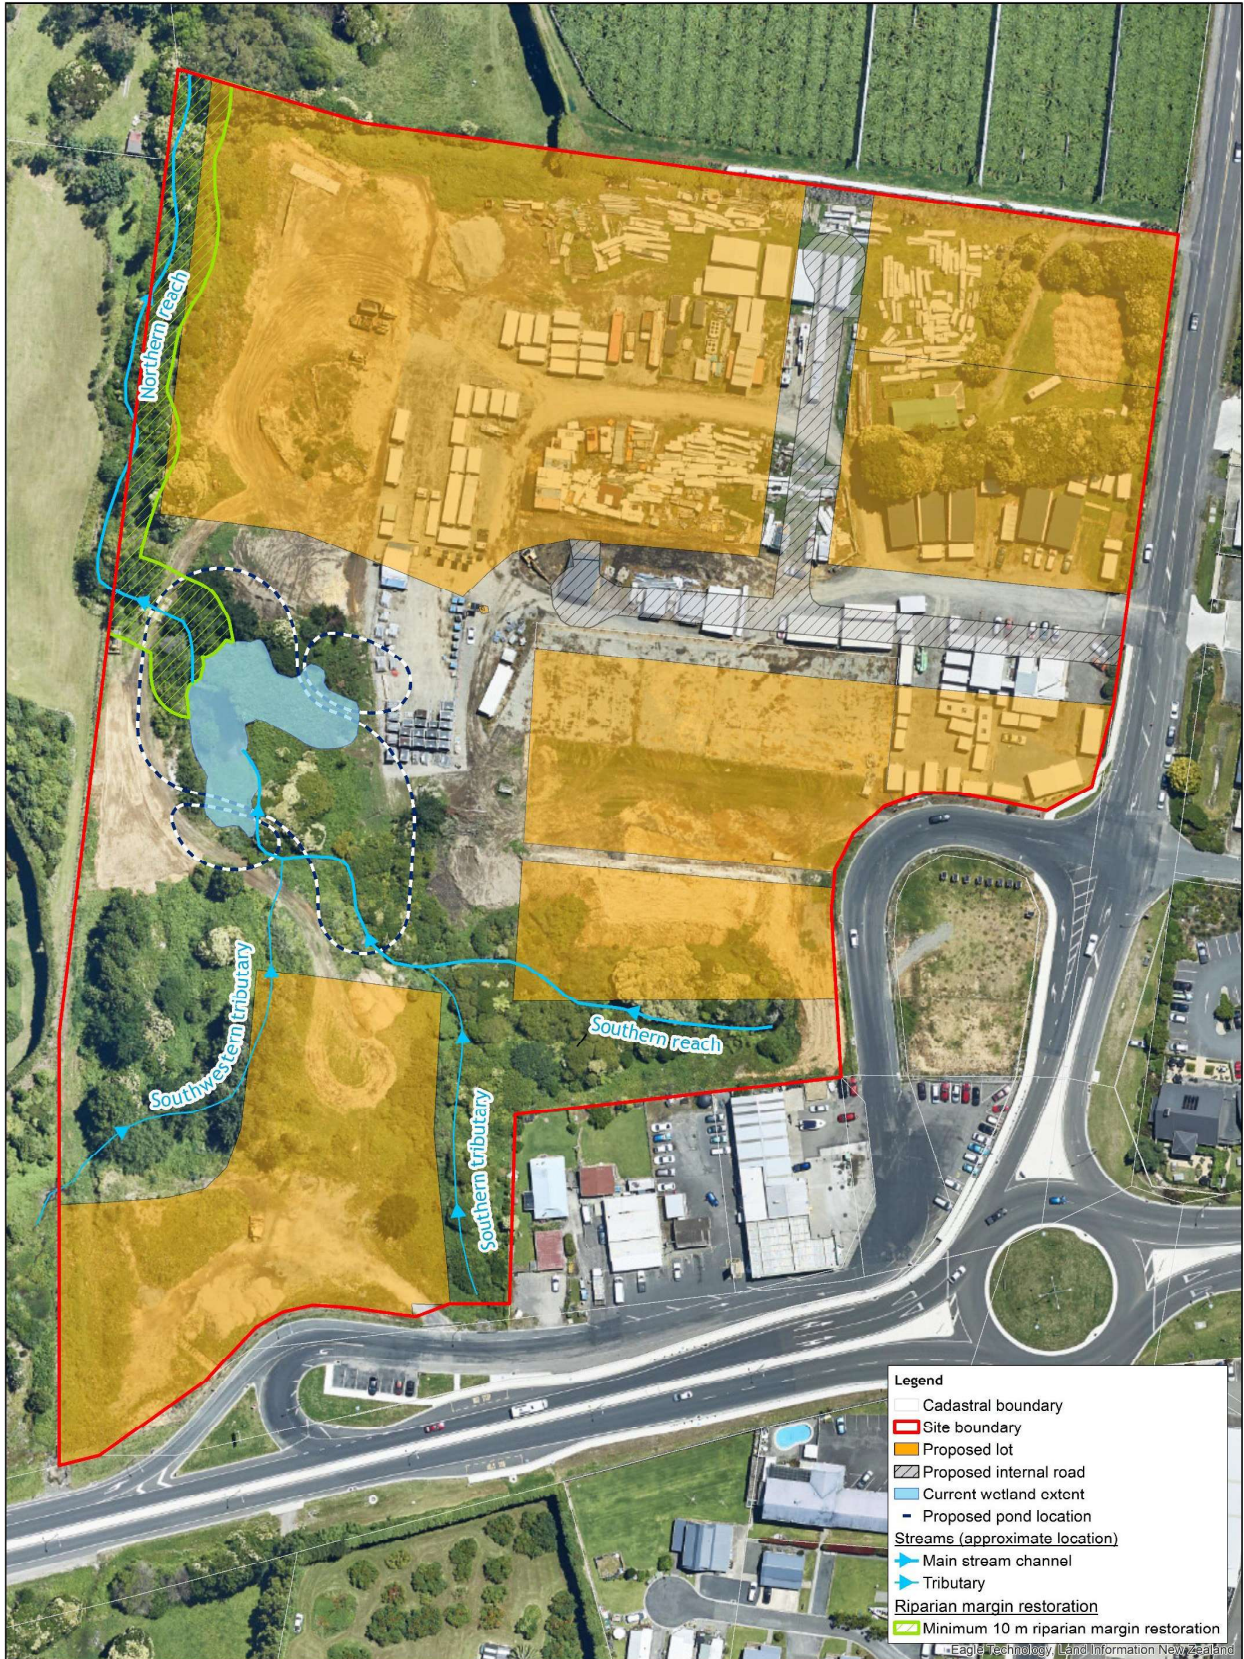
Figure 2. Proposed commercial development layout relative to current stream and wetland locations and proposed riparian margin enhancement at Te Puna Springs Estate.

It is proposed that all watercourses on the property will be retained in their current location with only the middle reaches being partially modified to enable construction of the retention and extended detention ponds (see Figure 2 and Appendix 2). A buffer zone will also be retained on both sides of each tributary in the southern half of the site, and along the eastern margin of the northern stream reach¹. The buffer zone will be planted with appropriate indigenous species.

Restoration and enhancement of the northern riparian margins should be undertaken in stages to ensure that blanket removal of the existing stream cover is not undertaken. Blanket vegetation removal would result in significant erosion as the soil on the slopes is very friable. Restoration and enhancement of the southern stream reaches would mainly comprise planting the riparian margins with appropriate indigenous species. Consideration could also be given to some instream enhancement measures to improve instream conditions for freshwater fauna.
