32 Athenree

Tauranga Harbour Coastal Erosion Assessment
 Erosion Hazard Overview
 Site 32: Athenree

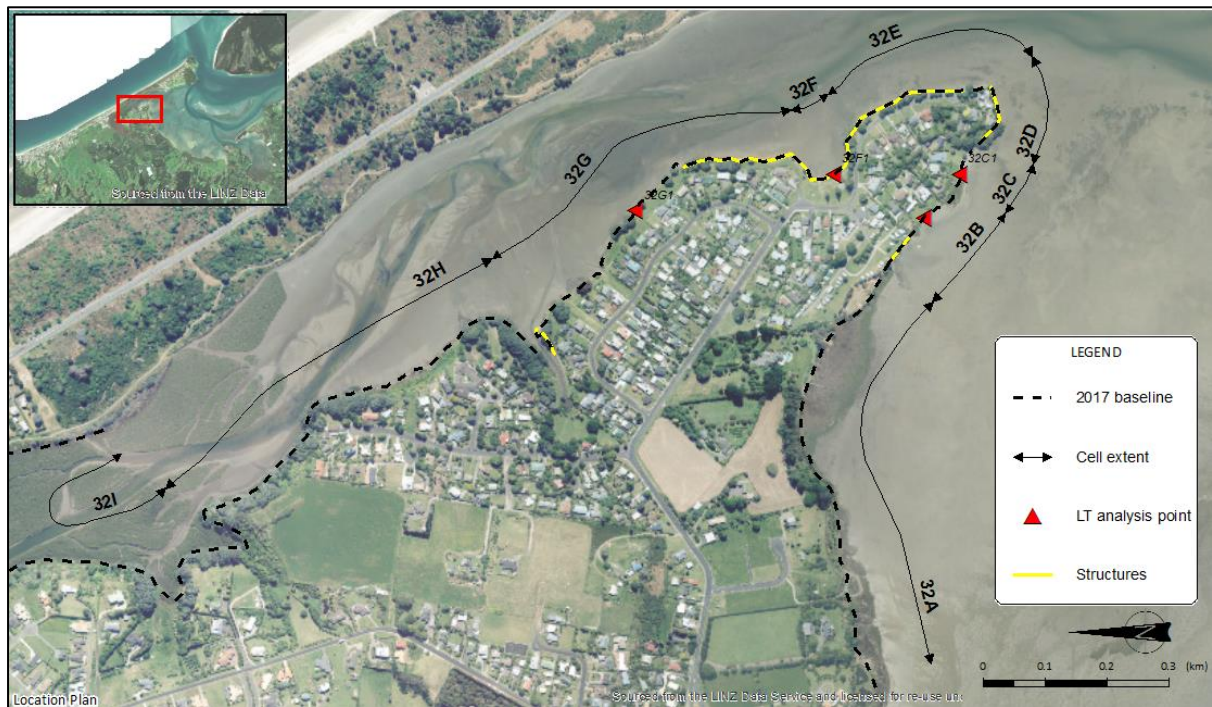
Figure 32-1 Location and cell extent along the Athenree shoreline within the Tauranga Harbour.

The Athenree shoreline is located at the northernmost end of the Tauranga Harbour. The site consists of approximately 2 km of consolidated shoreline and 4 km of low-lying estuarine area. The site is split into 9 cells based on differences in morphology, exposure and shoreline elevation (Figure 1-1). The eastern side of the shoreline is a relatively low energy environment with limited fetch and shallow intertidal flats.

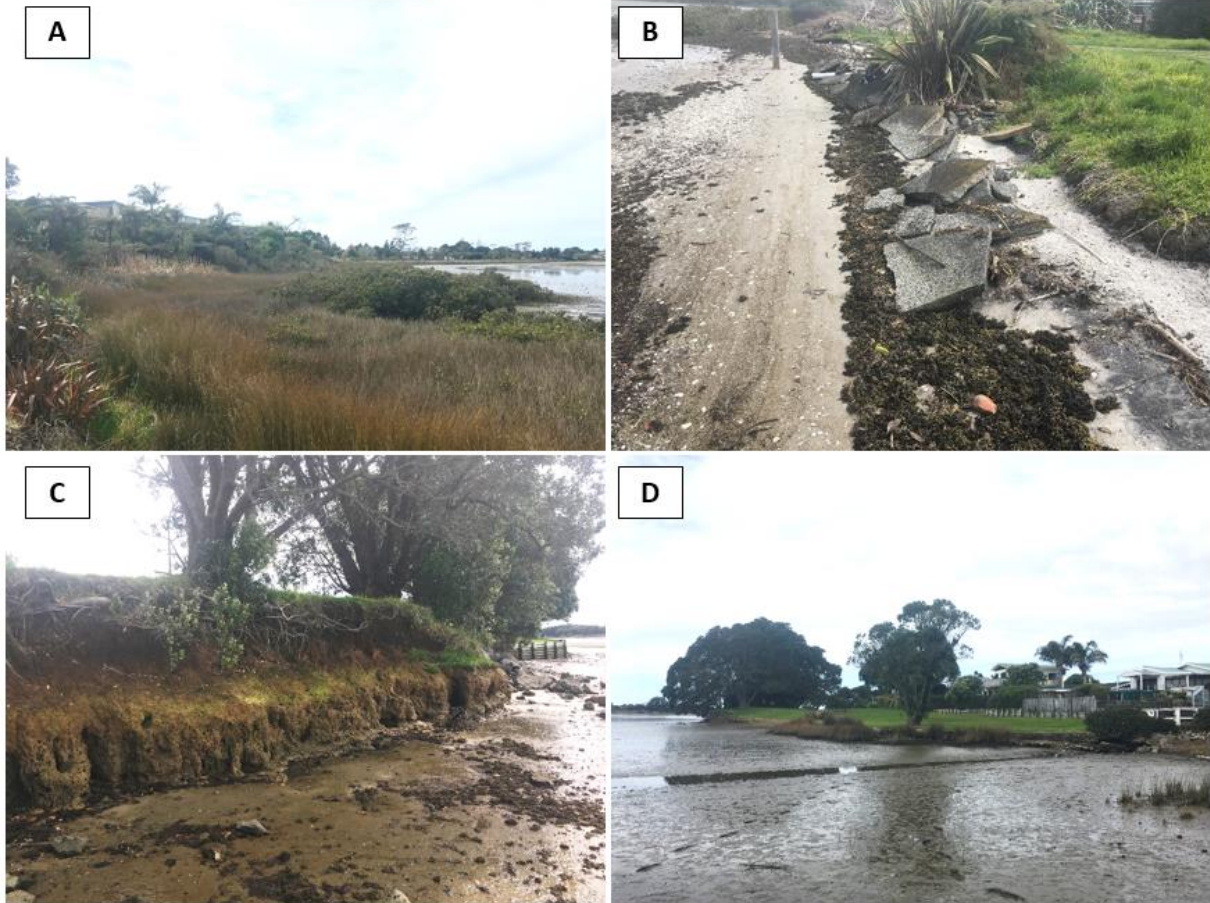
Figure 32-2 Site photos for Athenree. (A) Low-lying estuarine shoreline within Cell 32A. (B) Sandy high-tide beach (Cell 32C). (C) Consolidated bank (Cell 32E). (D) Sheltered, consolidated bank (Cell 32G).

At the western extent of the Athenree shoreline there is low-lying estuarine shoreline with mangroves and salt marsh vegetation (Cell 32A) (Figure 32-2). Towards east there is a southwest-facing consolidated bank which is elevated approximately 1 m high (Cell 32B). Cell 32C is characterised by a low grass bank fronted with a small sandy high tide beach (Figure 32-2). On the southern tip of Athenree the shoreline is characterised by consolidated bank, ranging in elevation from RL 2 to 3 m. The south-facing bank (Cell 32D) is exposed to an average fetch of 5 km from south.

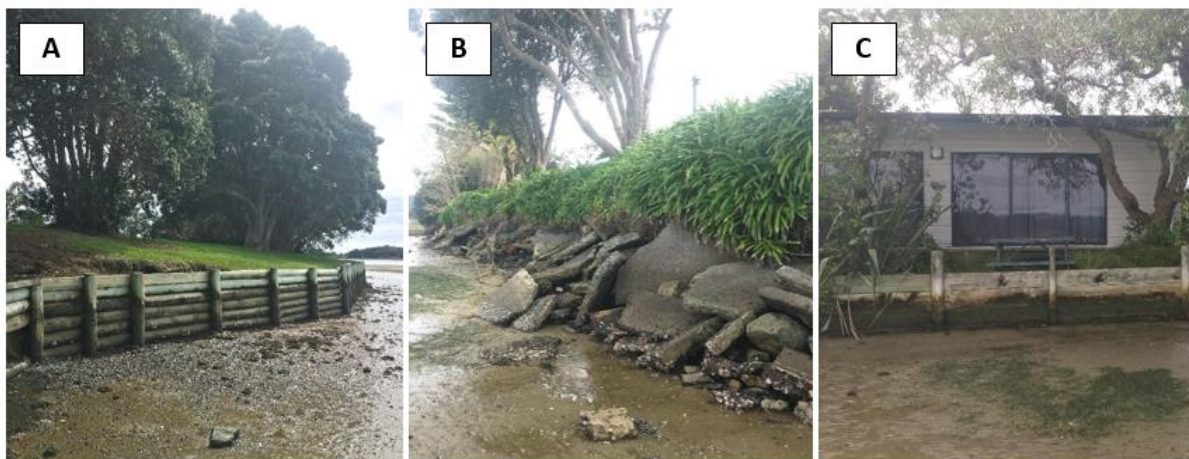
Figure 32-3 Examples of protection structures along the Athenree shoreline. (A) Timber seawall (Cell 32E), (B) section of riprap (Cell 32E), (C) timber seawall (Cell 32E)
