27 Omokoroa South

Tauranga Harbour Coastal Erosion Assessment
 Erosion Hazard Overview
 Site 27: Omokoroa South

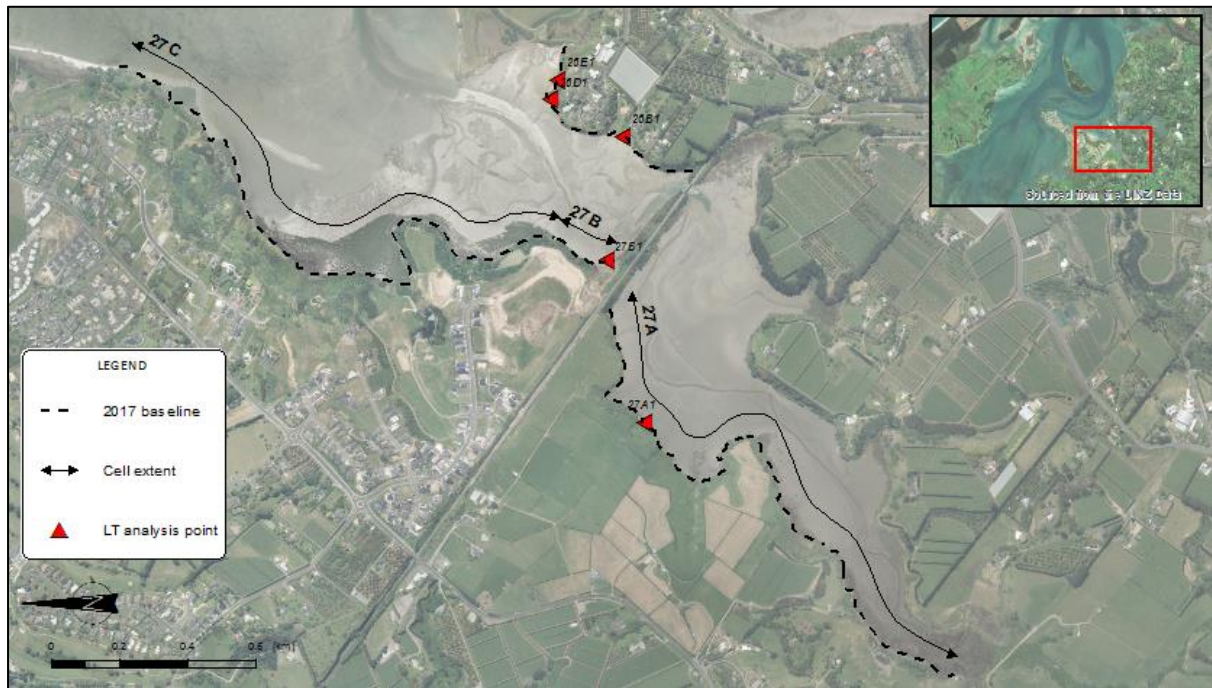
Figure 27-1 Location and cell extent along the Omokoroa South shoreline within the Tauranga Harbour.

The Omokoroa South shoreline is located on the southern side of Omokoroa Peninsula within the central part of Tauranga Harbour. The site consists of approximately 0.2 km of consolidated shoreline and 3.4 km of low-lying estuarine area. The site is split into 3 cells based on differences in exposure, morphology and shoreline elevation (Figure 27-1). The southern section of the site is very sheltered with an average fetch exposure of 0.5 km from the southeast. The northern section of the shoreline is slightly more exposed with an average fetch exposure of 2 km.

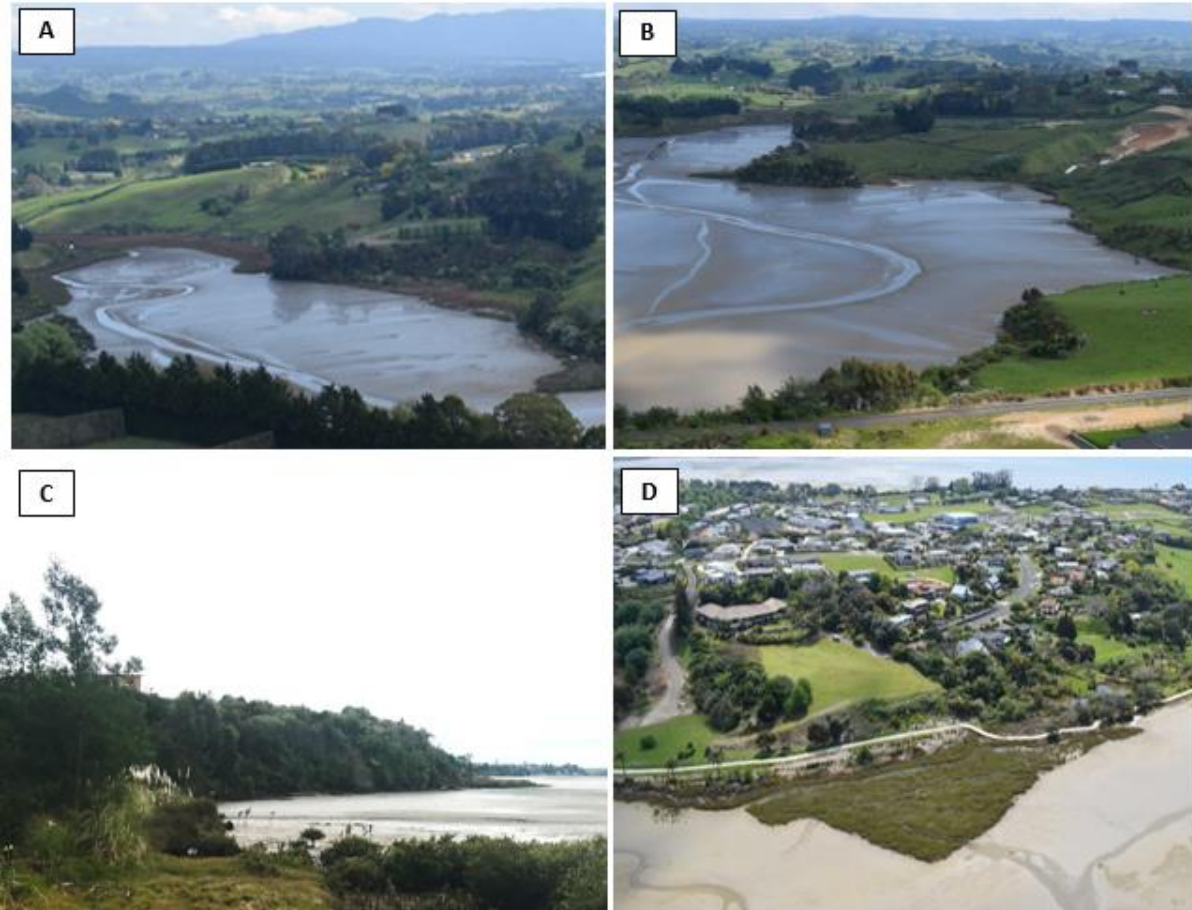
Figure 27-2 Site photos for Omokoroa South. (A, B) Low-lying estuarine shoreline (Cell 27A), (C) Well-vegetated cliffs (Cell 27B), (D) Low-lying estuarine shoreline (Cell 27C).

The shoreline on the southern side of the railway bridge is characterised by sheltered low-lying estuarine shoreline with patches of salt marsh and mangrove vegetation (Cell 27A). On the northern side of the railway bridge there is a small section of consolidated cliffs ranging in elevation from RL 11 to 15 m (Cell 27B). The cliffs are relatively sheltered and appear stable with dense vegetation. North from the cliffs the shoreline changes to another area of low-lying estuarine shoreline which is characterised by mangroves and salt marsh vegetation (Cell 27C).
