## 2 Tanners Point

**Tauranga Harbour Coastal Erosion Assessment**  
 Erosion Hazard Overview  
 Site 2: Tanners Point

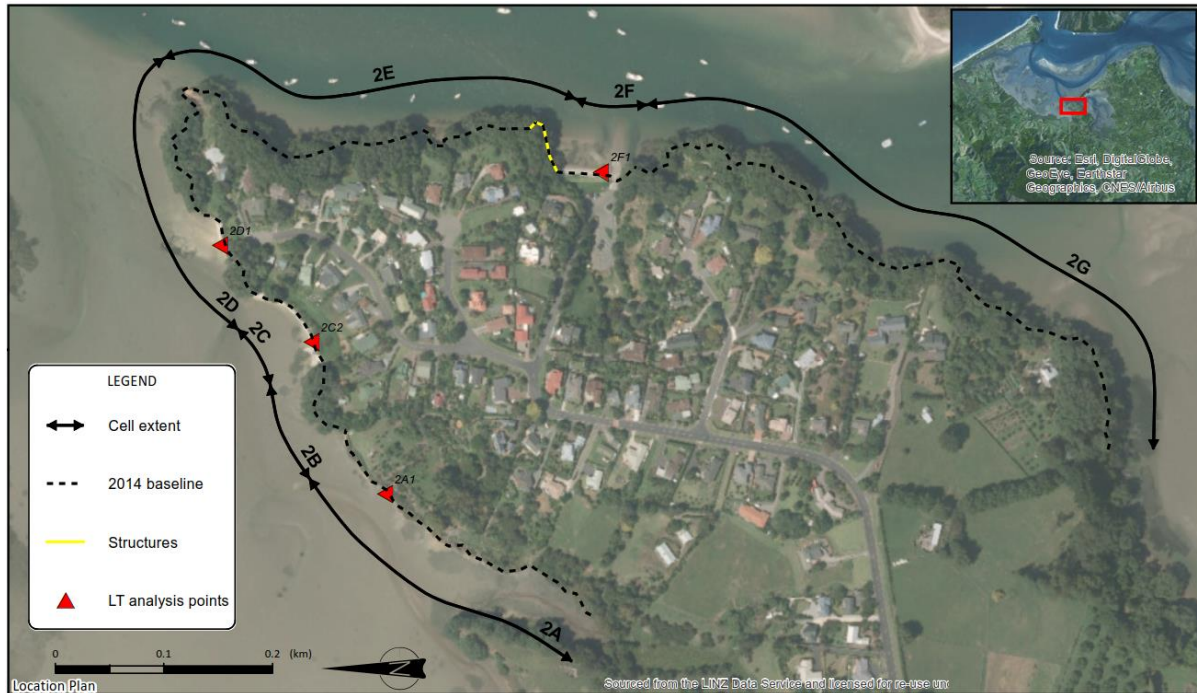
Tanners Point extends out into the northern basin of the Tauranga Harbour, approximately 3.5 km southwest from the Katikati Entrance. The shoreline consists of around 1.2 km of coastal cliffs and approximately 0.4 km of unconsolidated shoreline. The site is split into 7 cells based on differences in exposure, morphology and shoreline elevation (Figure 2-1).

Figure 2-1 Location and cell extent of the Tanners Point shoreline within Tauranga Harbour.

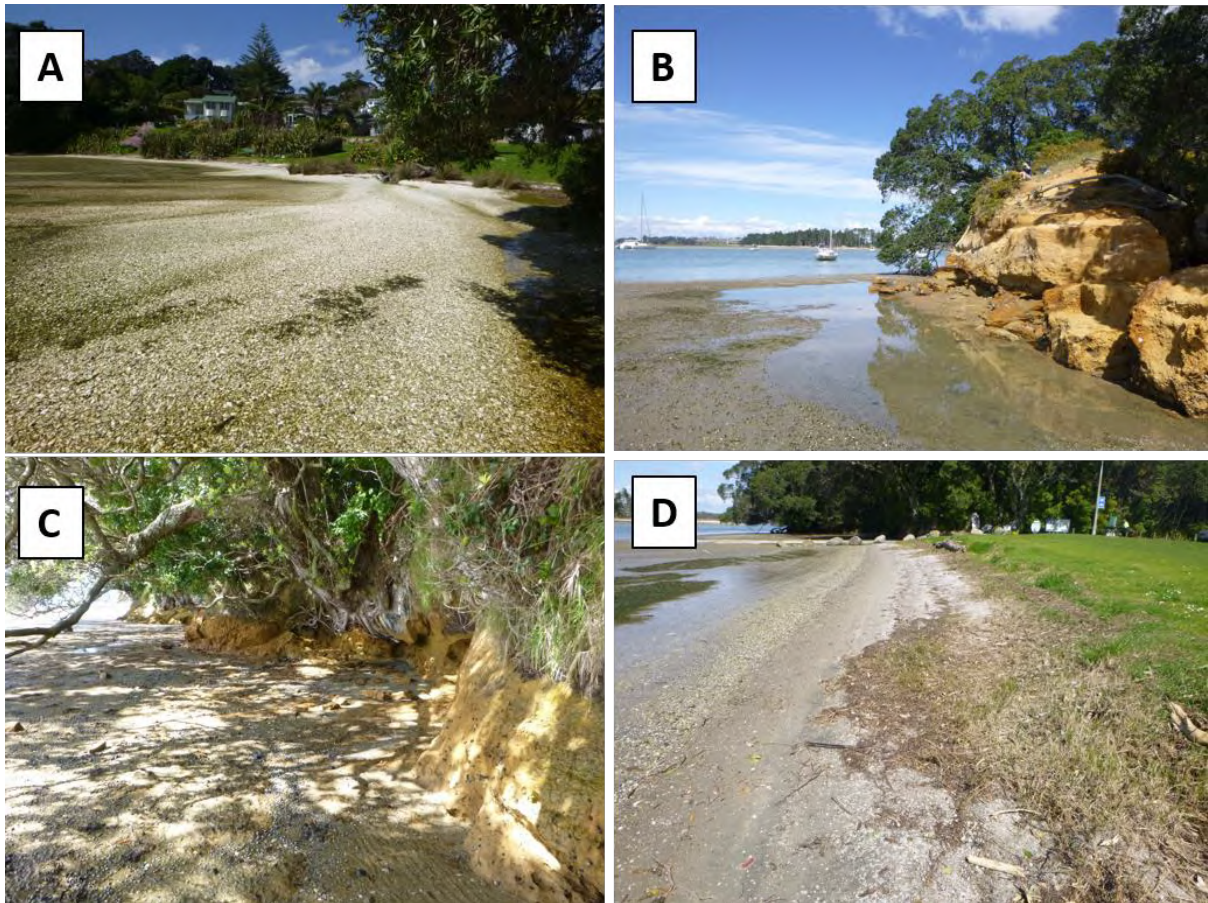
Figure 2-2 Site photos for Tanners Point. (A) Coarse shell berm (Cell 2C), (B) exposed cliffs at the tip of Tanners Point (Cell 2D), (C) cliff toe with dense pohutukawa overhanging (Cell 2E), (D) unconsolidated shoreline (Cell 2F).

The northern side of Tanners Point is relatively sheltered with a maximum fetch of 2 km from the north. At the western end of the north-facing side (Cell 2A), the shoreline gradually slopes to a low grass area with a backshore elevation less than 2 m above RL. Further towards the northeast is a small embayment (Cell 2C) bound by cliffs on either side, which range in elevation from RL 6 to 9 m (Cell 2B and Cell 2D). Within the embayment the shoreline gradually slopes to a grass reserve at approximately 2 m above RL. A small berm with dense accumulation of shells exists at the edge of the grass (Figure 2-2A).

The north-eastern tip of Tanners Point is characterised by coastal cliffs which stand between RL 6 to 9 m (Cell 2D) (Figure 2-2B). The cliffs are exposed to a fetch approximately 3 km across from Bowentown in the northeast. The cliffs continue around the eastern side of the shoreline and run parallel to Tuapiro Channel (Cell 2E). The east-facing cliffs range in elevation from RL 10 to 22 m and are densely vegetated with large, overhanging pohutukawa trees (Figure 2-2C). A shore platform, approximately 10 m wide, extends from the base of the cliffs to the edge of Tuapiro Channel. The east-facing cliffs are orientated with direct exposure to the open ocean through the Katikati Entrance. However, there is approximately 0.5 km of intertidal flats in the middle of the harbour which are likely to dissipate most wave energy.

North from the boat ramp at the end of Tanners Point Road (Tanners Point Recreational Reserve) the unconsolidated shore gradually slopes up from the Tuapiro Channel and transitions to a very narrow high-tide beach which is backed by a grass reserve (Cell 2F) (Figure 2-2D). South from the boat ramp are more densely vegetated cliffs.

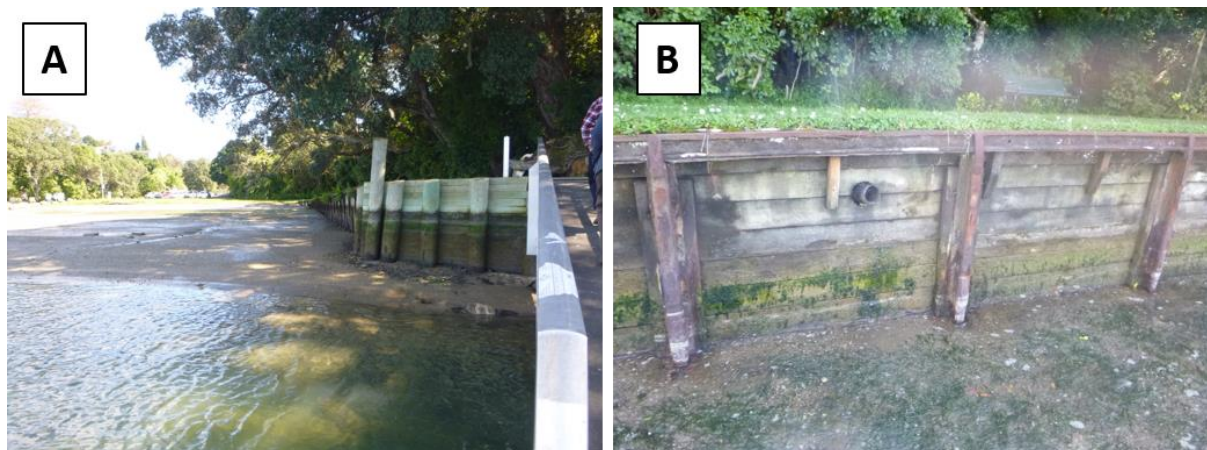
In addition to the boat ramp at the end of Tanners Point Road, there is a timber seawall at the northern end of the Tanners Point Recreational Reserve (Cell 2F). The structure is approximately 1.5 to 2 m high and appears relatively good condition. The structure runs parallel to the grass bank where a jetty/pontoon extends out into the edge of the Tuapiro channel (Figure 2-3).

Figure 2-3 Examples of protection structures around Tanners Point. (A) Timber seawall and pontoon (Cell 2F), (B) timber seawall at the edge of grass reserve (Cell 2F).

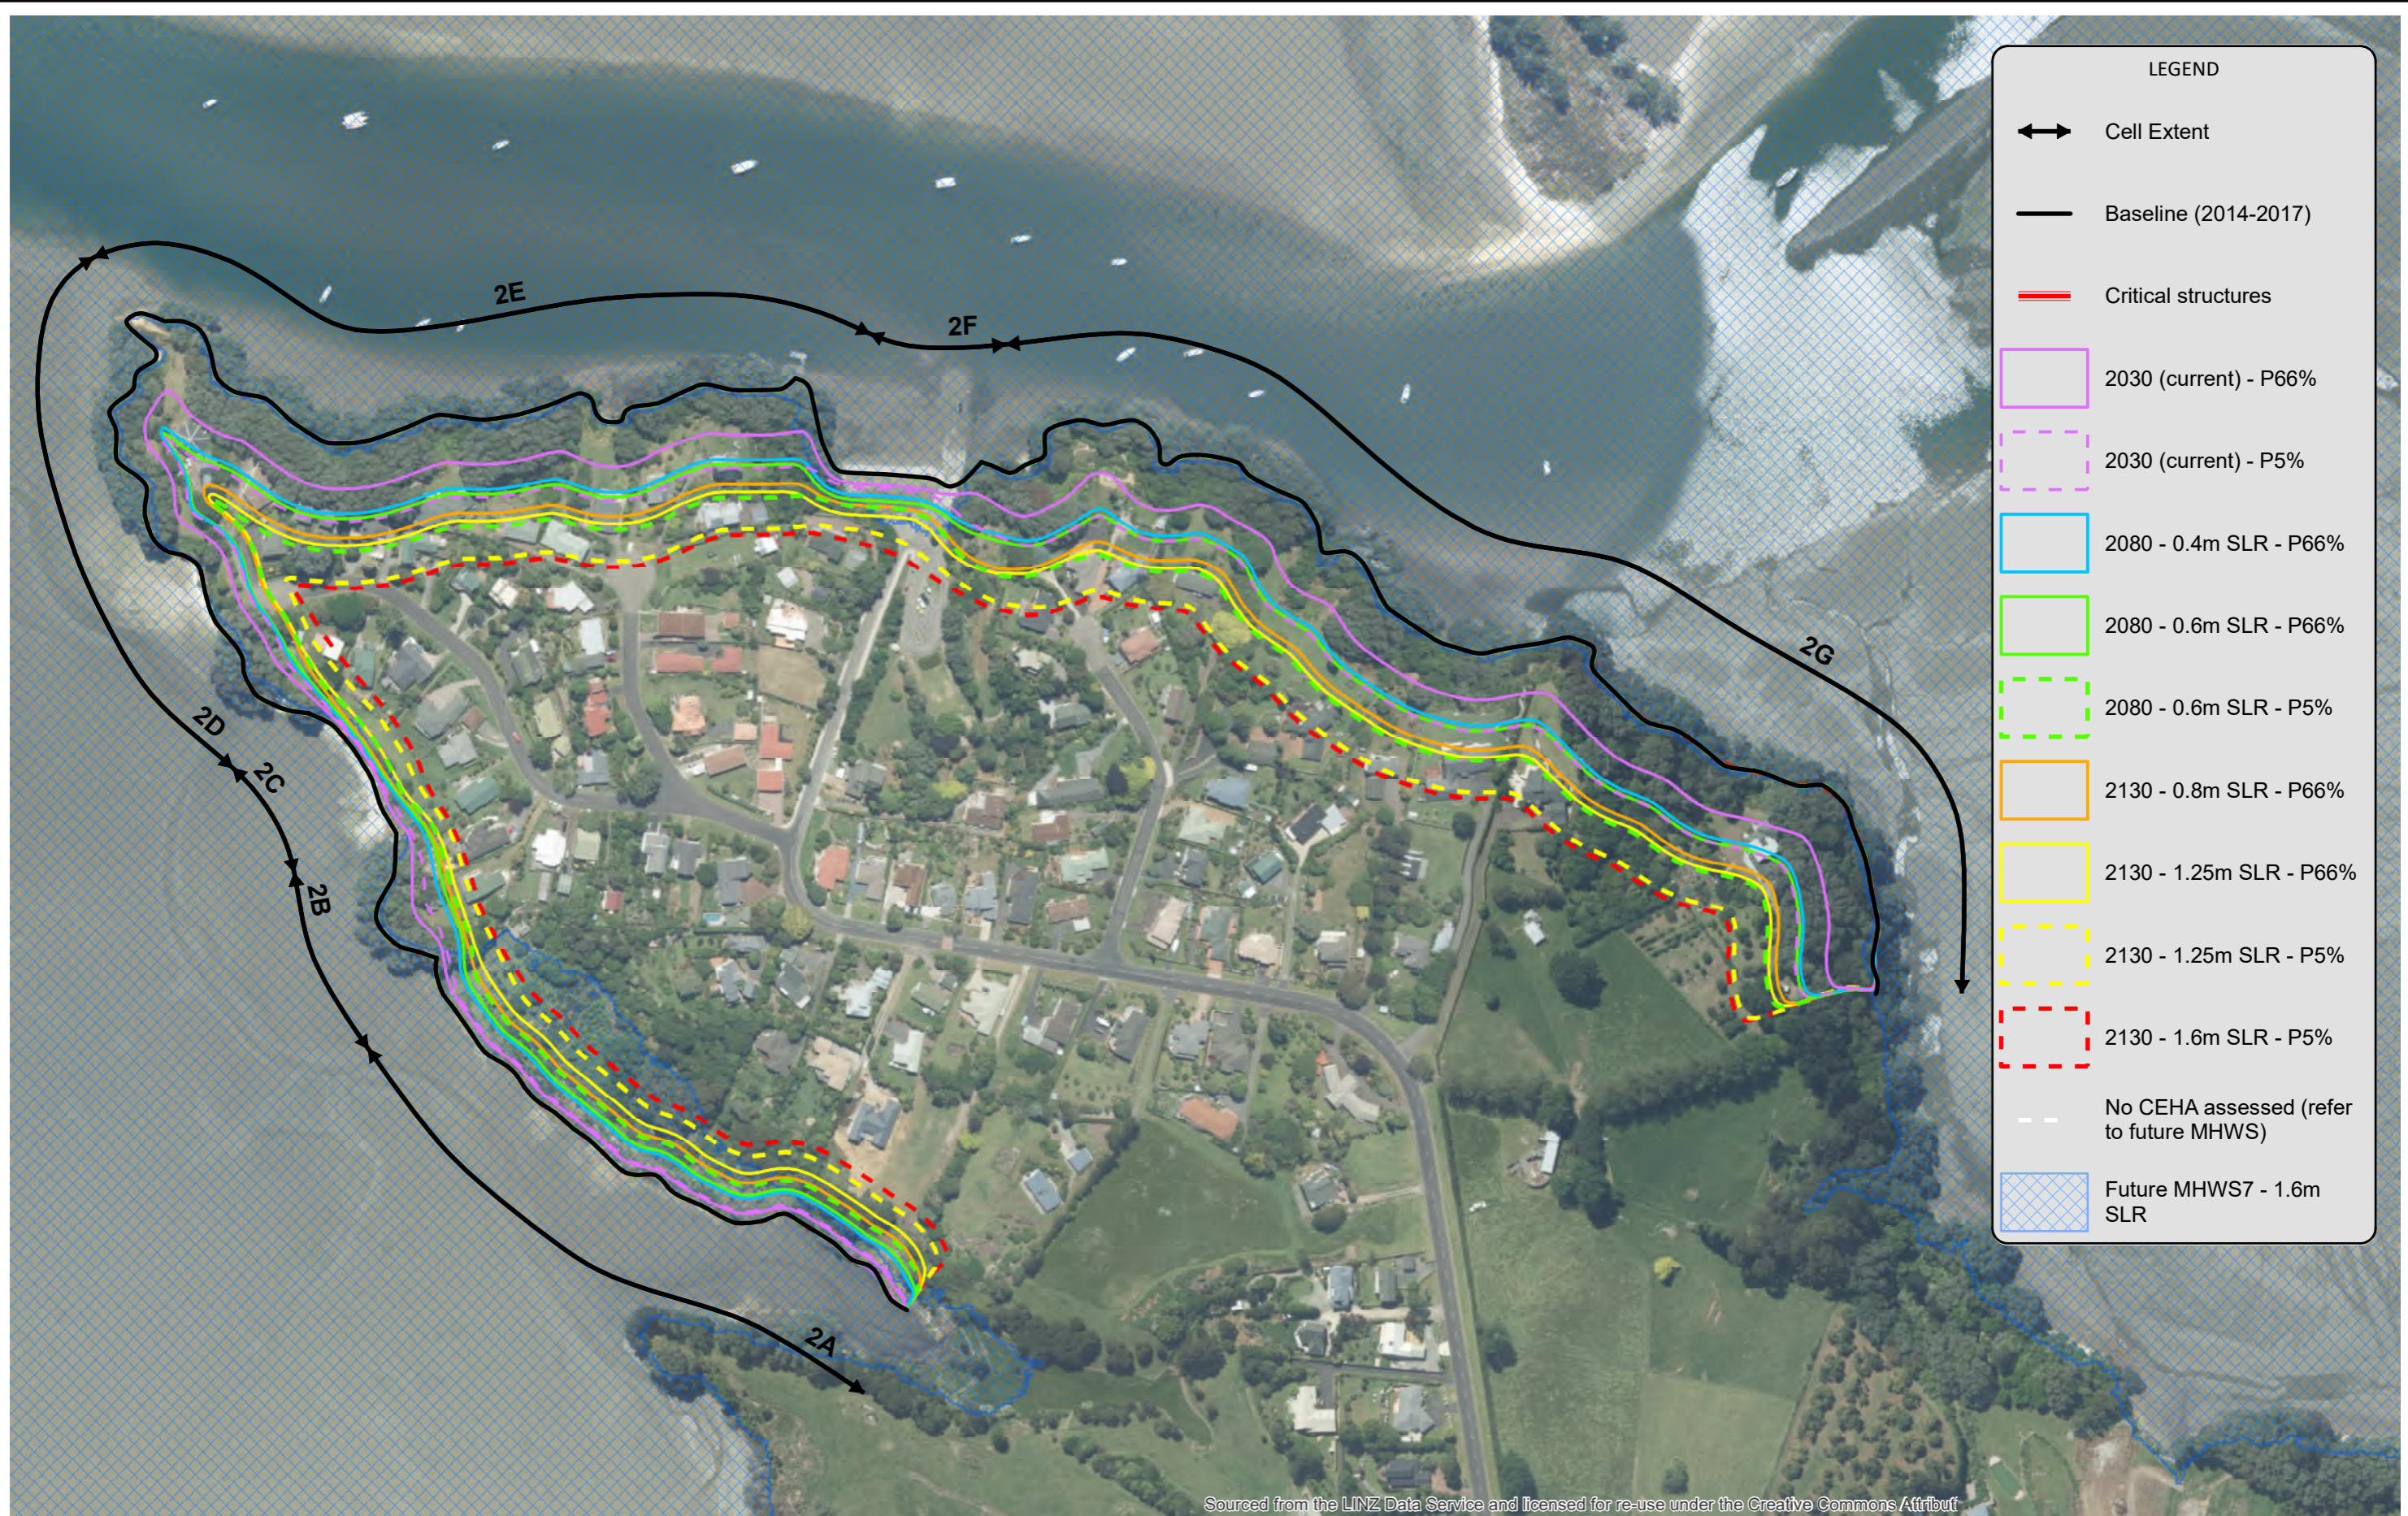
FIGURE No. Figure 2-4

Coastal erosion hazard distances for Tanners Point are presented within Table 2-2 and an overview map in Figure 2-4. Histograms of individual components and resultant erosion hazard distances using a Monte Carlo technique are shown in Appendix B. For the purpose of this assessment all coastal erosion protection structures have been ignored (refer to main report Section 4.5.4).

The current P<sub>66%</sub> erosion hazard ranges from -3 m to -5 m for the unconsolidated shoreline and from -16 m to -23 m along the cliffs.

The P<sub>5%</sub> for 1.6 m SLR in 2130, ranges from -22 m on the sheltered, unconsolidated shoreline to -70 m along the exposed, east-facing cliffs. The large future values along the cliffs is due to the large fetch exposure and hence a high SLR response factor.
