**IN THE MATTER** of Proposed Private Plan Change  
95 to the Western Bay of Plenty  
District Plan First Review –  
Pencarrow Estate, Pongakawa

**STATEMENT OF EVIDENCE OF JAMES ABRAHAM ON BEHALF OF  
WESTERN BAY OF PLENTY DISTRICT COUNCIL IN RESPONSE TO  
QUESTIONS FROM HEARING COMMISSIONERS  
(WASTEWATER AND STORMWATER)  
22 November 2024**

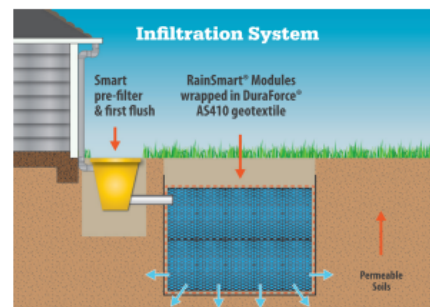
**Flushing:** When the tank is deemed to be ineffective the sediment can be flushed out. This requires identifying the exact location with a metal detector (assumes metallic tape at corners) or from as-built plans and digging a small access trench at each end of the module. This allows access for water to be pumped in at one end and suction cleaned at the other. After flushing the geotextile will need to be patched as per the installation instructions.

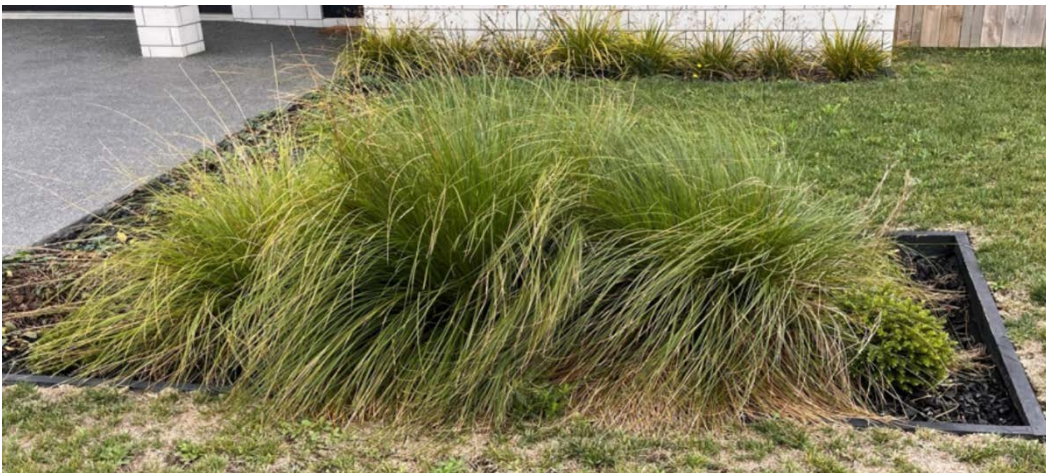
*Figure 3: Compliant rain garden with good vegetation*

#### **Compliant**

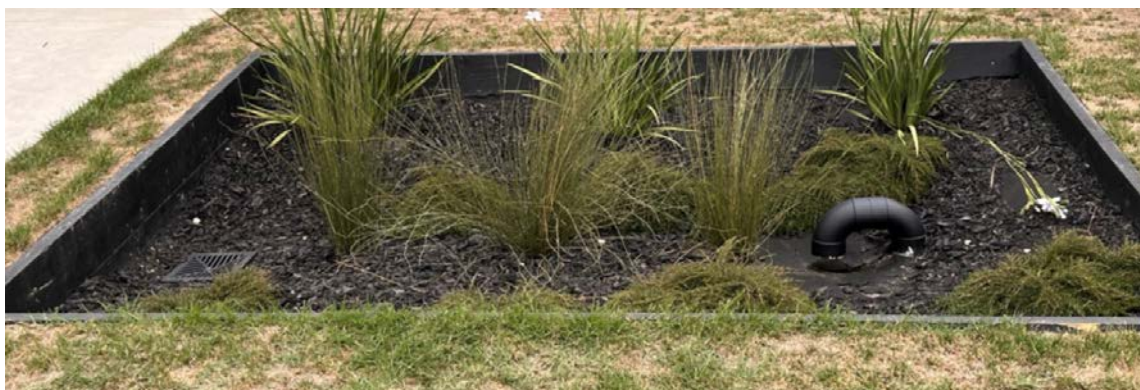
*Figure 5: Rain garden with improved plant density required*

**Minor non-compliance**

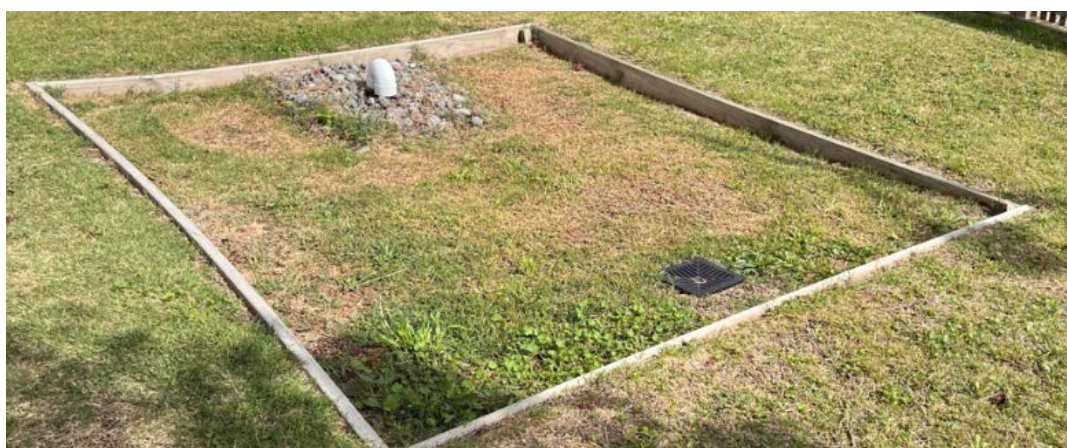
*Figure 7: non-compliant raingarden with no vegetation*

**Non compliant**

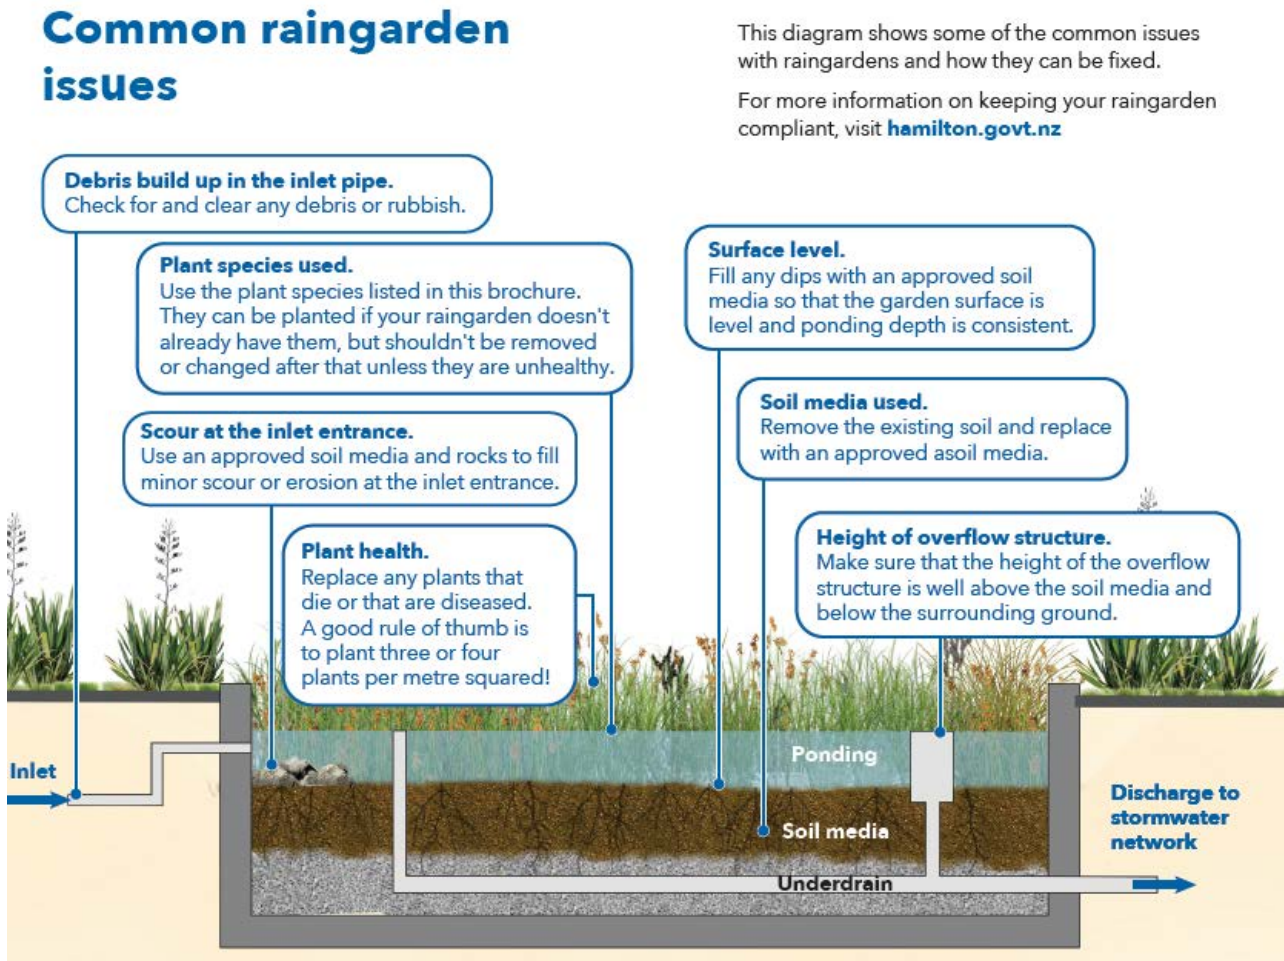
Figure 10: Example from the rain garden educational brochure

This was then further supported by the educational brochures sent with the letters, which outlined how residents were able to rectify these issues. Figure 10 shows an extract from the raingarden educational brochure:
